**Slope Failure Repair using Polyfelt® PEC at Jalan Gunung Raya,
Langkawi, Malaysia.**

Polyfelt® PEC slope failure repair

Jalan Gunung Raya -Langkawi, Malaysia

Project	: Langkawi Kedah Darul Aman, Malaysia
Application	: Reinforcement of a 35m-high slope using sandy soil backfill
Owner	: Public Works Department (PWD), Malaysia
Products Used	: TenCate Polyfelt® PEC 150

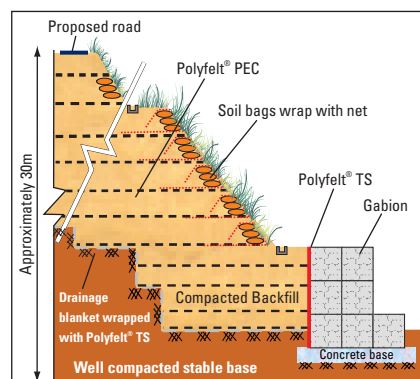
the structure was formed by wrapping a net around bags filled with fine-grained soil. This method of construction facilitates the practical construction of a curved slope. TenCate Polyfelt® PEC was laid behind the gabion and soil bags to strengthen the structure (Figure 1). A layer of TenCate Polyfelt® TS geotextile filter was placed behind the gabions to prevent soil piping through the voids in the gabions.

Figure 1: Proposed reinforced wall.

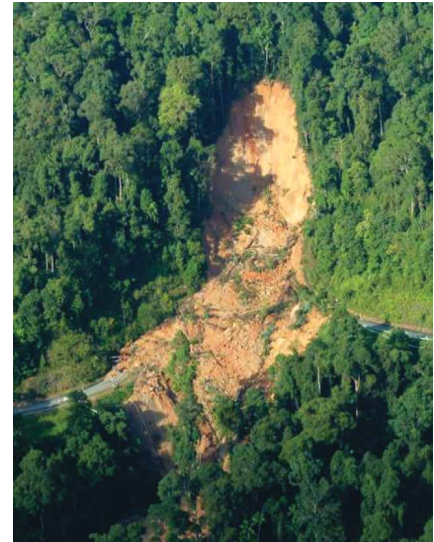
Continuous rainfall resulted in a major landslide on the Federal Route that leads to the highest mountain (881m) in Langkawi which houses a museum, a park and a satellite control centre. The landslide significantly disrupted traffic and posed a danger to road users.

Figure 2: Aerial view of the slope failure.

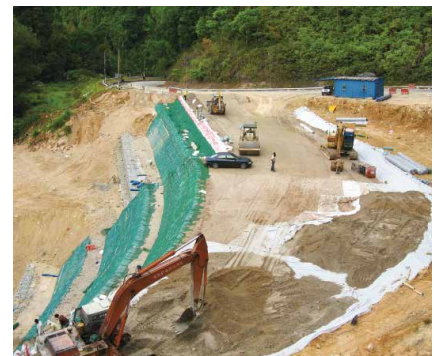
Figure 3: Reinforcing slope with Polyfelt® PEC.

The primary reinforced direction of TenCate Polyfelt® PEC reinforcement geotextile was installed perpendicular to the slope's surface. Pretensioning of the reinforcement geotextile was done by pegging it in position with the aid of wooden pegs. Compaction of backfill material was done using a 10 ton compactor to achieve a minimum of 90% proctor compaction. Hydro seeding was carried out after the slope was completed for a vegetated surface.

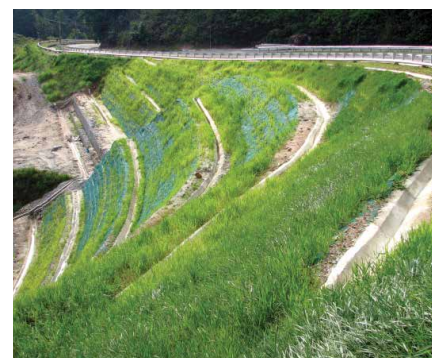
Figure 4: Vegetated slope after completion.
