Geotube[®] Mine Wastewater Management at MMG Gold Mine, Tasmania

The MMG Rosebery mine in Tasmania is a productive, rich underground mining operation that has been producing gold, zinc, copper and lead concentrates for over 80 years. Waste slurry from the process plant is deposited into two tailings dams; a primary, older Tailings Storage Facility (TSF) near maximum capacity plus a newer, smaller one.

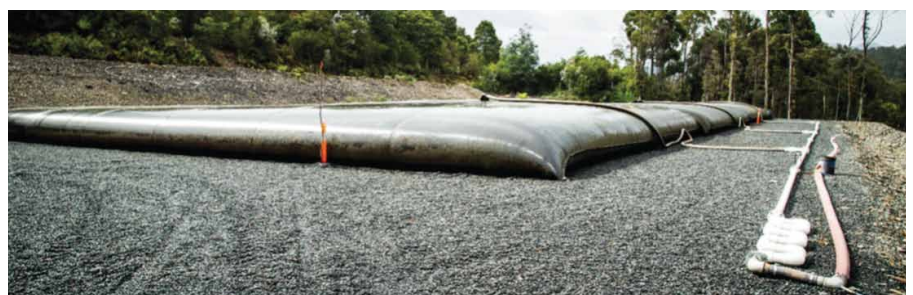
Dewatering of the polishing ponds

Dewatering and cleaning up the polishing ponds involved establishing a dewatering pad and polymer dosing unit near a fresh water source 600 m away from the furthest pond. The tube pad elevation was 23 m higher than the lowest pond, requiring use of booster pumps to deliver the slurry to the tubes.

The volume of sediment in the ponds was calculated, and three Geotube® GT500D units with a circumference of 36.6 m x length of 30.6 m were installed.

Slurry dredged from the ponds was dosed with polymer mixed on site. The operation was subject to regular audit by the mine and environmental authorities, and proceeded without incident.

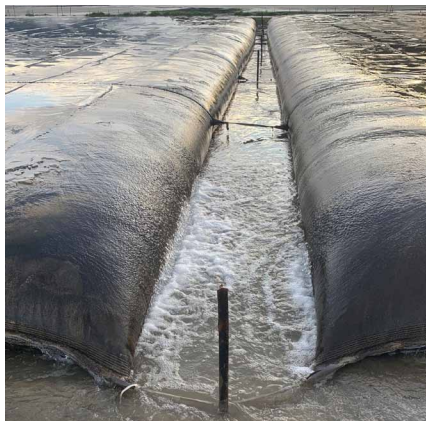
Geotube® Dewatering at work

The first six units of Geotube® were deployed in groups of two, with a gap between each set. Two tube units at a time were then pumped with water containing a very low solids content (0.5%) at 600 l/sec without polymer dosing. Water discharge from the tubes was rapid and clear.

As operations proceeded, it became apparent that the high volume of water discharged was softening the tailings beneath the inner (open dam side) of the tubes more than the outer (wall side) of the tubes, resulting in uneven settlement and the failure of one end seam of one tube with discharge from the seam failure dispersed out towards the center of the dam.

Geotube® units perform at their best when pumped slurry uniformly fills the tubes and evenly tensions the tube fabric. Uneven filling or distorted settlement prevents uniform fabric tensioning and increases the risk of tube failure.

Examination of the failed tube found that there was no settlement down into the tailings at the outer (wall end) and settlement of 750 mm ~ 1 m down into the tailings at the inner (dam side) of the tube. Inspection of the failed tube showed that solids within the intact bulk portion of the tube were well dewatered and firm, indicating good dewatering functionality up to rupture.

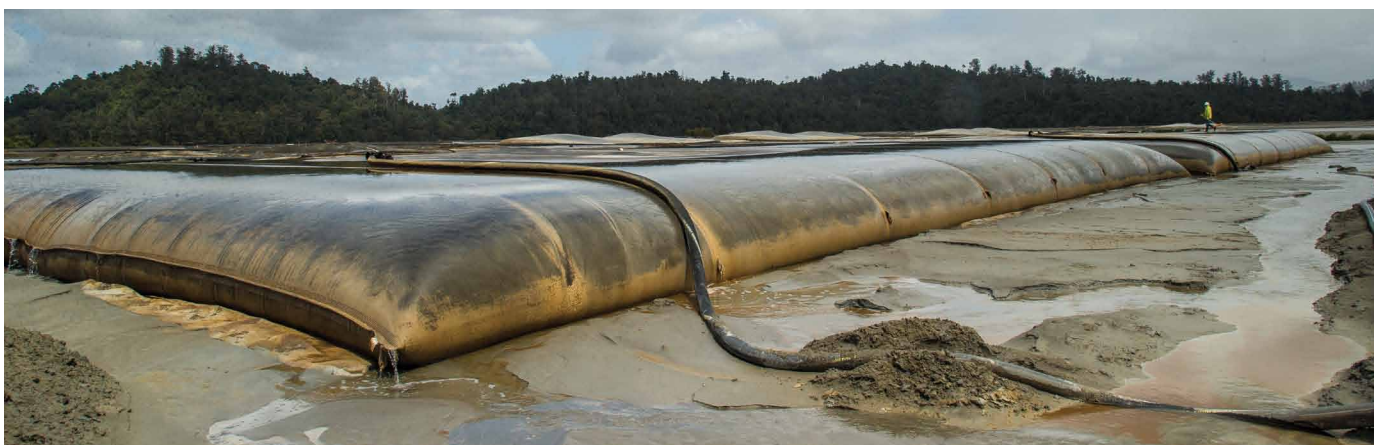
Geotube® units installed over soft tailings

As the project proceeded, additional Geotube® units were required to be laid further and further away from the firm tailings against the wall into increasingly soft conditions out in the dam. Access out over the soft tailings was improved by laying bidim™ nonwoven geotextile, and the tube units laid over geomembrane which directed water discharge from the tubes out into the dam, away from the tubes themselves.

In total, 38 large Geotube® units each with a 1,000 m³ sediment capture volume were deployed, with 32 tubes installed over very soft tailings that was very difficult to access.
